**Flood Control Project Maintenance
Levee Inspections**
LMA District Cover Sheet
Spring 2017 Levee Inspection Results

Sutter Maintenance Yard Nelson Bend

Waterway			Bank	Unit Miles
Unit No. 01 Feather River West Levee - Nelson Bend				0.50
	Spring (March - May)	Summer (June - August)	(September - November) Fall	Winter (December - February)
Unit Maintenance Rating (Fall Only)				
Date of Inspection	4/6/2017 - 4/6/2017			
DWR Inspector	Sterling York			
Accompanied By	Steve Beckley

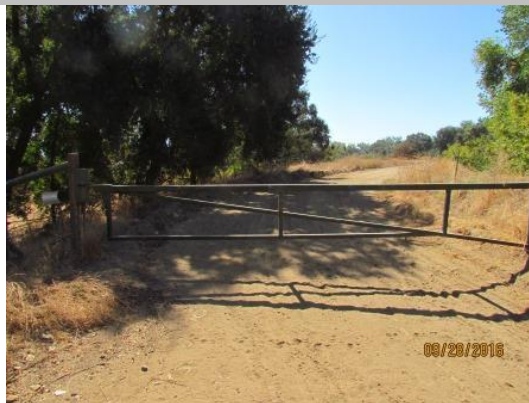
Photo 1 of 1 : SP_2017_ST0006_471_7_20170316_00003.jpg

LM Start	0.01	Rating **	U	Issue No.	7
LM End	0.04	Issue Type +	En	Location *	CR
Category	Earthen Levee			GPS Latitude/Longitude	
				Start	End
Item	Encroachments			38.887006 °	38.886591 °
				-121.614735 °	-121.614956 °
DWR ID	DWR_ST0006_01_f_2012_7

Comment Code					
FE : Fence					
Inspector Comment					
A landowner has constructed a gate on the crown that hinders inspection of this unit. The unit was inaccessible for the fall 2012 season and was not inspected. The unit was accessible during the spring 2013 inspection, but was difficult to open and should be monitored. Met with landowner to perform spring 2015 inspection, and he should be contacted to open the gate for future inspections. The land owner is David Lowry his phone number is (925) 606-2403. He will open the gate for inspections but will not allow the LMA to put a lock on the gate, and the LMA does not do any maintenance to this levee.

View of fence and gate that only has land owners lock on it beginning of levee looking downstream. Fall 2016.

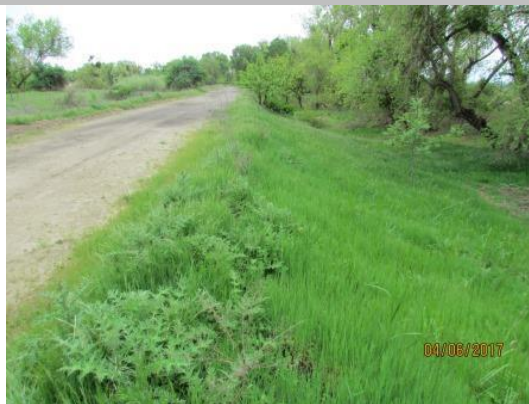
Photo 1 of 1 : SP_2017_ST0006_471_15_20170410_00008.jpg

LM Start	0.02	Rating **	U	Issue No.	15
LM End	0.42	Issue Type +	Ma	Location *	WS
Category	Earthen Levee			GPS Latitude/Longitude	
				Start	End
Item	Vegetation			38.886883 °	38.881287 °
				-121.614797 °	-121.614490 °
DWR ID	DWR_ST0006_01_f_2015_15				
Comment Code					
V2 : Remove the wild growth other than native grasses from the levee slopes.					
Inspector Comment					
Remove the vegetation and trim up the trees 5 feet for visibility.

View of the vegetation along the waterside slope looking downstream. Spring 2017.

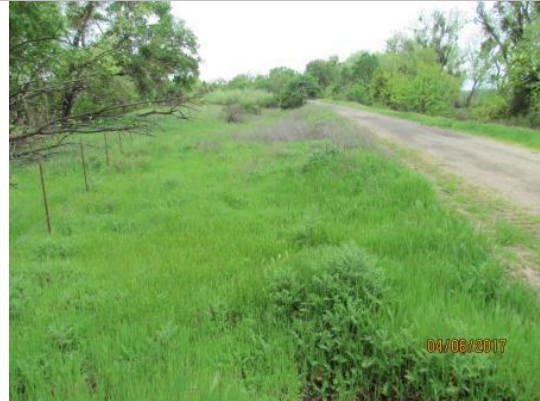
Photo 1 of 1 : SP_2017_ST0006_471_2_20170410_00007.jpg

LM Start	0.02	Rating **	U	Issue No.	2
LM End	0.46	Issue Type +	Ma	Location *	LS
Category	Earthen Levee			GPS Latitude/Longitude	
				Start	End
Item	Vegetation			38.886883 °	38.880833 °
				-121.614797 °	-121.614387 °
DWR ID	DWR_ST0006_01_f_2015_2				
Comment Code					
V2 : Remove the wild growth other than native grasses from the levee slopes.					
Inspector Comment					
Remove the vegetation, wild growth, and trim up the trees 5 feet for visibility.

View of the vegetation along the landside slope looking downstream. Spring 2017.

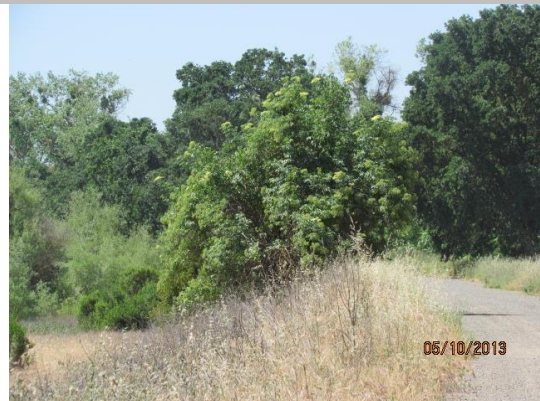
Photo 1 of 1 : SP_2017_ST0006_471_4_20170316_00002.jpg

LM Start	0.06	Rating **	M	Issue No.	4
LM End	0.06	Issue Type +	Ma	Location *	WS
Category	Earthen Levee			GPS Latitude/Longitude	
				Start	End
Item	Vegetation			38.886277 °	38.886277 °
				-121.615129 °	-121.615129 °
DWR ID	DWR_ST0006_01_s_2012_4				
Comment Code					
V4 : Elderberries are blocking visibility and flood fight capability.					
Inspector Comment					
Elderberries are partially blocking visibility.

View of the elderberries that are blocking visibility.

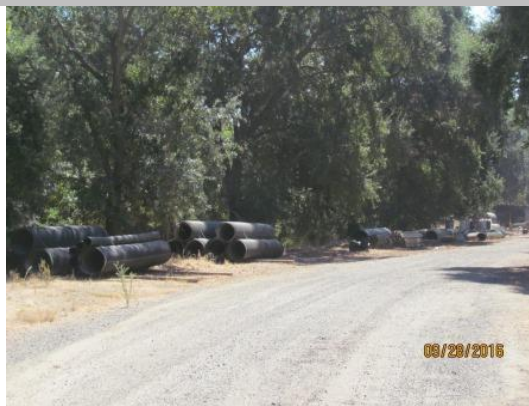
Photo 1 of 1 : SP_2017_ST0006_471_16_20170316_00006.jpg

LM Start	0.40	Rating **	U	Issue No.	16
LM End	0.46	Issue Type +	En	Location *	WS
Category	Earthen Levee			GPS Latitude/Longitude	
				Start	End
Item	Encroachments			38.881638 °	38.880795 °
				-121.614647 °	-121.614427 °
DWR ID	DWR_ST0006_01_f_2015_16				
Comment Code					
DE : Debris					
Inspector Comment					
The large pipe is laying along the waterside berm.

View of the pipe along the waterside berm looking downstream. Fall 2016.

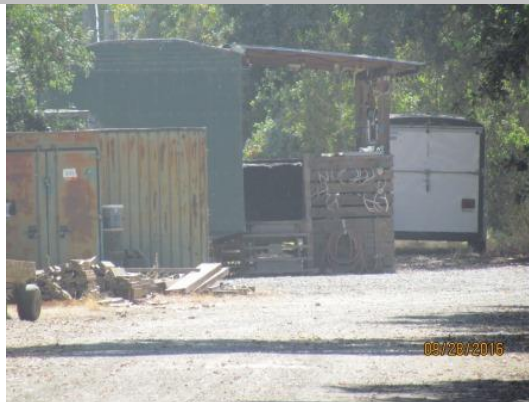
Photo 1 of 1 : SP_2017_ST0006_471_8_20170316_00004.jpg

LM Start	0.47	Rating **	U	Issue No.	8
LM End	0.47	Issue Type +	En	Location *	CR
Category	Earthen Levee			GPS Latitude/Longitude	
				Start	End
Item	Encroachments			38.880664 °	38.880664 °
				-121.614335 °	-121.614335 °
DWR ID	DWR_ST0006_01_s_2012_8				
Comment Code					
BU : Building					
Inspector Comment					
The building is directly behind the pipe that is laying along the waterside berm.

View of the building directly behind the pipe on the waterside berm looking downstream. Fall 2016.
